Towards a  
*People-Friendly*  
Town Centre for  
Clapham Junction

# One Year Follow-up

*An evaluation of changes one year following our initial report proposing suggestions for the improvement of Clapham Junction Town Centre from the Wandsworth Cycling Campaign*

October 2003

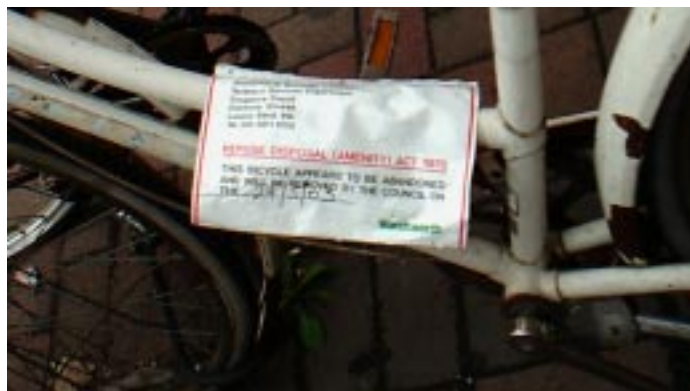
With the exception of the increased provision at Eckstein Road (see below) we noted no new Sheffield stands or other cycle parking facilities in the town centre. However, the tagging and removal of abandoned cycles has been implemented and this may have contributed to a reduction in the number of abandoned cycles on the 18 stands immediately outside the main entrance of Clapham Junction Station from 13 in 2002 to 5 in the present survey. This represents a significant improvement in the useable capacity for cycle parking at

this convenient location for access to this major interchange. However, one of the abandoned bicycles had been tagged for removal by the end of May 2003 (i.e. four months before the date of the survey!), suggesting that further improvements might be achieved by better co-ordination between the street

patrollers and those responsible for the removal. The cycle stands outside the station were fully occupied at the time of both these surveys, indicating that there is still a great need for further cycle parking provision in this area. We also noted that there is still no secure bicycle parking at Clapham Junction Station; the latest information we have on this (as at October 2003) indicates that discussions between the Council and the landowners in the area are in progress that may result in additional cycle parking becoming available in the vicinity. We feel that it may also be possible to provide some cycle stands in the Prested Road/St John's Hill area, near the fitness club, to augment the ideally located stands immediately adjacent to the main station entrance.

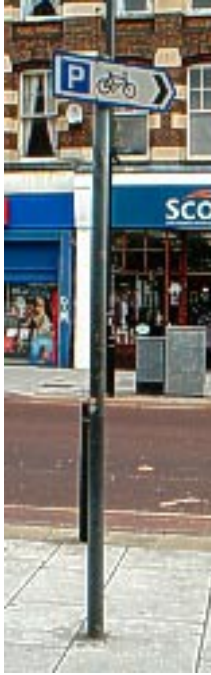
In our previous report we suggested that the useful but discreet cycle parking provision at the junction of Aliwal Road with St John's Road could be highlighted by a cycle parking sign. We were pleased to see that this had been implemented. Unfortunately, the sign had become twisted round to point in the wrong direction at the time of our visit. However, it proved possible to correct this. This raises the issue of maintenance – is this not something that street patrollers could be looking out for?

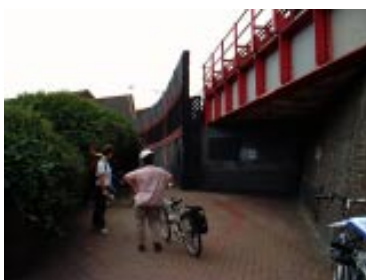
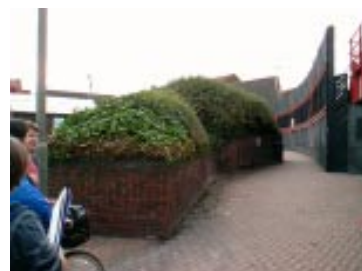
The planted beds appeared well tended and the shrubs had been cut to a much shorter length than at the time of the original survey. However, the area is still poorly lit and pedestrian-unfriendly. However, we understand that the Council are in discussions with the landowner, ShopStop, regarding improvements to this area.

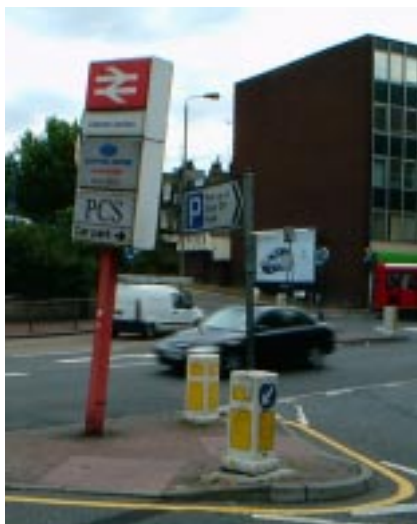
*Southern end of Falcon Road, from the railway bridge to the junction with St. John's Hill (pages 11-12)*

If anything, we felt that this area had deteriorated since the previous visit. The general impression is of abandonment and dereliction.

The very poor lighting under the railway bridge remains unchanged and the area is still dirty and littered.

The narrow pavement on one side of the corner of Falcon Road and Falcon lane was almost completely blocked by overhanging shrubs at the time of our visit.

The road environment is still dangerous, particularly in the area of the mini-roundabout as previously described. Vehicles cutting the corner of Falcon Lane and Falcon Road have damaged the paving on the North side. (The pothole highlighted in the previous report was repaired after two calls to the Council).

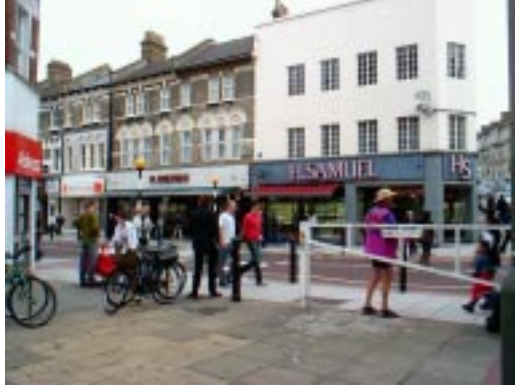
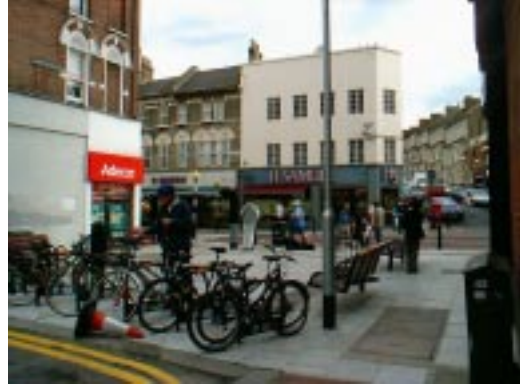
We were pleased to see that the area near the junction of Eckstein Road with St John's Road had been landscaped, with the provision of cycle parking and benches and that preparations had been made for the planting of two trees. We were also pleased to note that a sign had been installed indicating the cycle parking on Aliwal Road (although see comment above suggesting lack of maintenance of this sign).

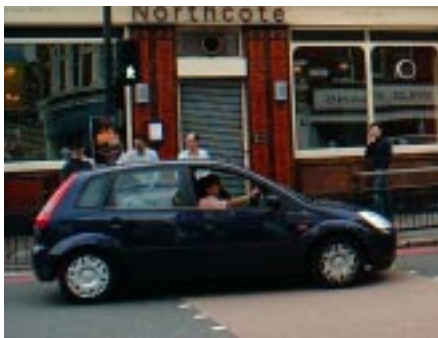
*Junction of Battersea Rise, St John's Road and Northcote Road (pages 15-16)*

The combination of narrow pavements and a completely unacceptable timing for the pedestrian crossing lights still act to sever this area. No improvements were noted in traffic flow and the lights still give pedestrians a mere five seconds to cross after a wait of almost one and a half minutes – assuming the crossing is not blocked by vehicles. Measures to keep this junction clear remain a top priority.
